DTC	P0234	Turbo/Super Charger Overboost Condition
DTC	P0299	Turbo/Super Charger Underboost
DTC	P1251	Turbo/Super Charger Overboost Condition (Too High)

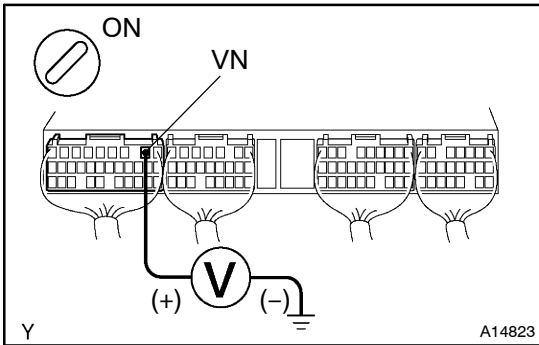
Check voltage between terminal VN of engine ECU connector and body ground.

Measure the voltage between terminal VN of the engine ECU connector and body ground.

Voltage: 9 to 14 V

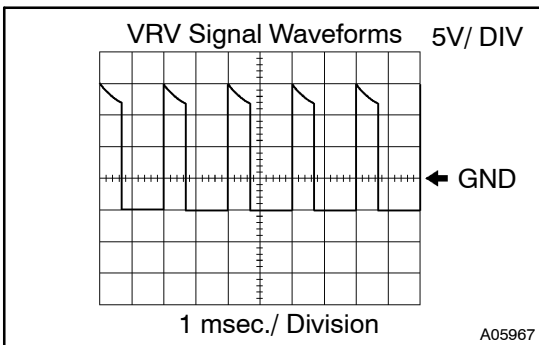
Reference: INSPECTION USING OSCILLOSCOPE

During idling, check the waveform between terminals VN and E1 of engine ECU connector.

The correct waveform is as shown.

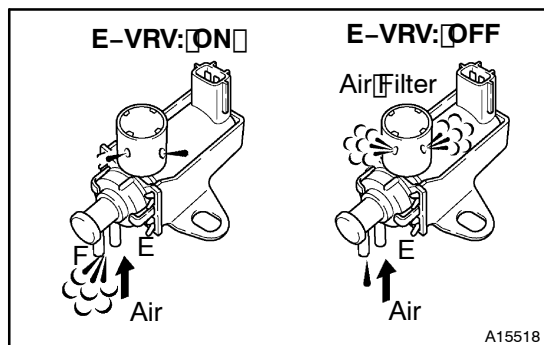
5 Check operation of E-VRV for intake pressure change.

- Disconnect the vacuum hoses from the E-VRV.
- Connect the hand-held tester to the DLC3.
- Turn the ignition switch to ON and the turn hand-held tester ON.
- Select the ACTIVE TEST mode on the hand-held tester.

Check the operation of the E-VRV when it is operated using the hand-held tester.

Air from port E flows out through port F.

Air from port E flows out through air filter.

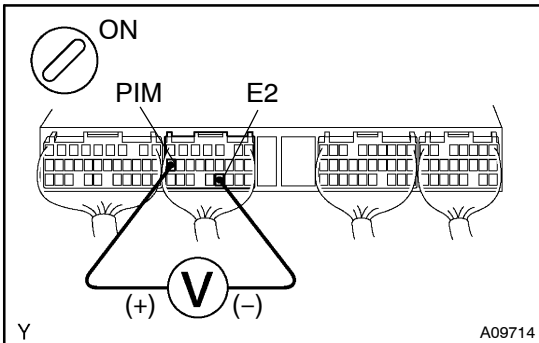
10	Check voltage between terminals PIM and E2 of engine ECU connector.
----	--

- (a) Remove the glove compartment door.
- (b) Turn the ignition switch to ON.

Even if the voltage output from the manifold absolute sensor is within the standard level, there may be a problem in the sensor by age deterioration.
